### Airprox report number 2019031

# **Summary of Airprox Information from UKAB**

Date: 22 Feb 19 Time: 1730 Position: 5118N 00042W 3nm NE Farnborough Altitude: 1600ft

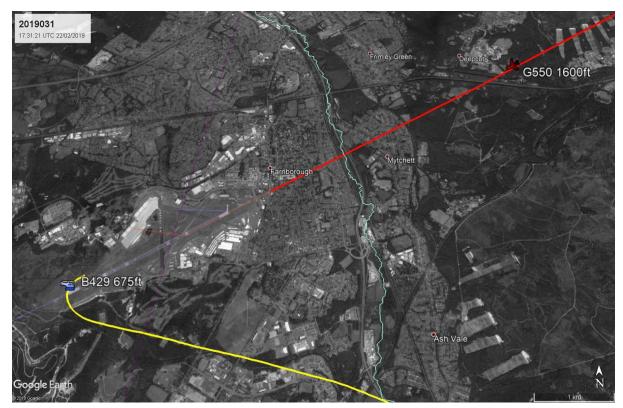
Reporting Gulfstream G550; red track Bell B429; yellow track

ADS-B data revealed that at the time the reporting aircraft was at the position/ height/ time reported on the ILS for Farnborough runway 24, a Bell 249 Global Ranger helicopter passed over the upwind end of RW24, descending through 1000 feet, heading for the Heli Foxtrot aiming point, between F3 and the West 2 Apron.

Given that it was a few minutes before sunset, and the helicopter was in the brighter part of the sky when viewed from the reporting aircraft, it would have been viewed as a 'black object' (silhouette).

The helicopter was approximately 7.7km ahead of the reporting aircraft, and would have been viewed side-on. The Bell 249 has a fuselage length of 13m, which would appear to be the same size as a typical drone (33cm) viewed from 212 metres. 'A small black object'.

The helicopter would doubtless have been displaying navigation and anti-collision lighting - which could be confused with LEDs on a drone. As the helicopter descended it would have disappeared into the ground clutter and runway lighting, etc.

ARC concluded that it was almost certainly the case that the reporting aircraft misidentified this distant helicopter as being a drone, much closer to them.
